# UPS FLIGHT 2976 RESPONSE

# Incident – UPS Flight 2976

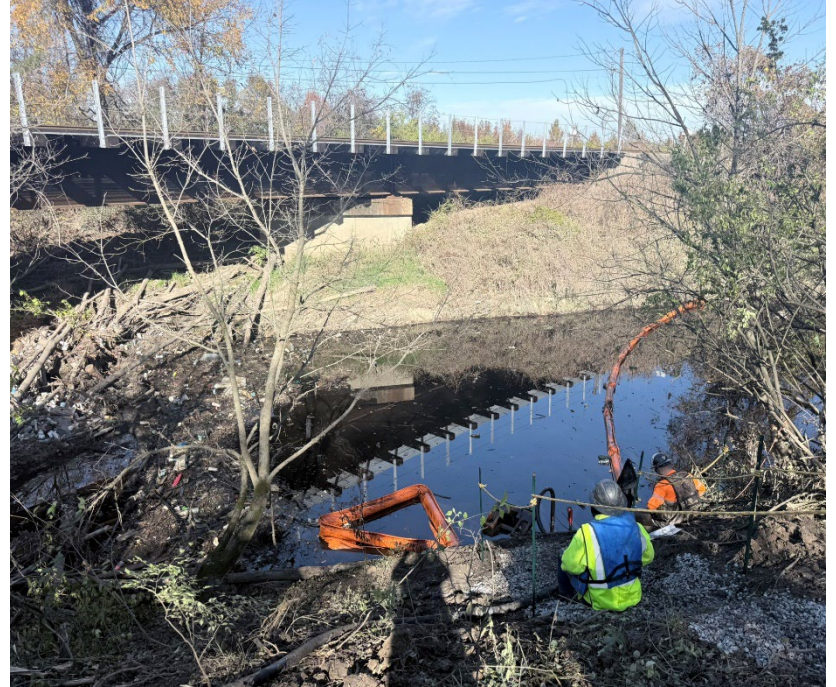
# CSX property

- Coordinate track crossings for crews
- Tree dam was removed after oil was recovered

- Two areas identified for additional activities
  - ▣ Lamborne Blvd ~ 5 miles downstream furthest downstream impact
  - ▣ CSX Property – Fallen tree dam holding back over foot of product approximately 0.5 miles from the entry point
- Still need to deal with the tanks that still contain oil
  - ▣ Estimated 100,000 gallons of oil still remain in damaged tanks

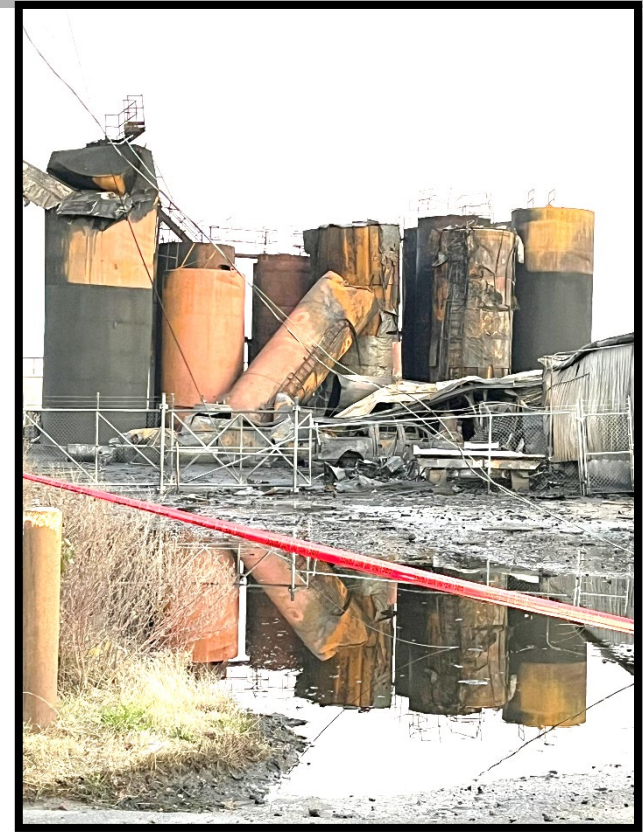
# Recovery from Tanks (source control)

- ❑ GFL estimated 100k gallons of oil remaining in damaged tanks
- ❑ Crane utilized for stability during removal
- ❑ Coordination of efforts:
  - ❑ Airport/FAA (proximity to flightline)
  - ❑ NTSB (recovery of fin as evidence)
  - ❑ Louisville EMA (access to area)
  - ❑ GFL (property owner)

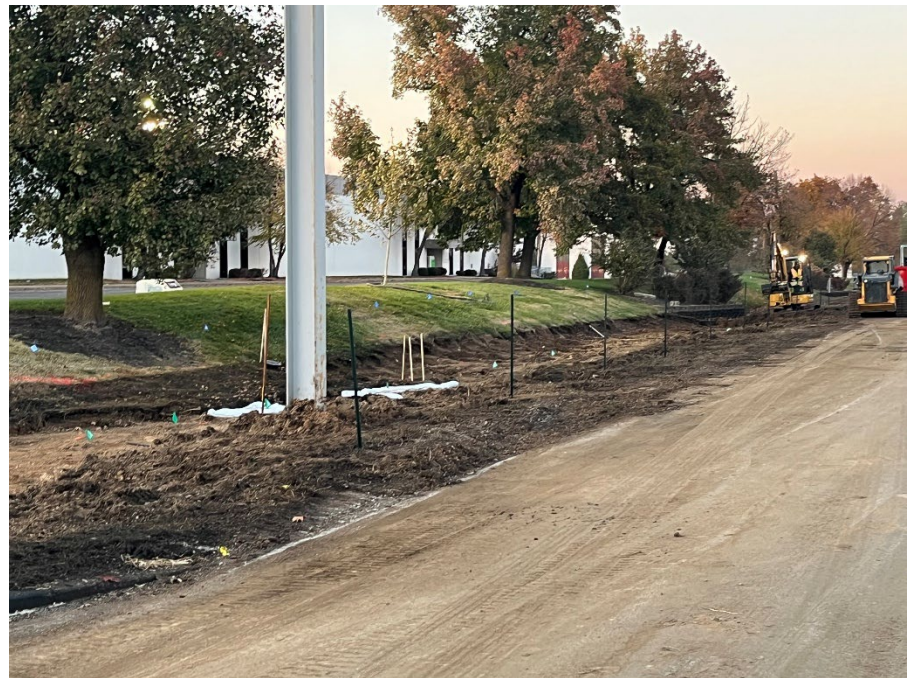
# Recovery Actions (KDEP)

- ❑ KDEP Recovery actions
- ❑ Right of way excavations have been completed (with some remaining hot spots being left to address)
- ❑ Utilities have been replaced in the right of way of Grade Lane
- ❑ Agreed Order with KDEP was signed in March 2026
- ❑ Gallons of petroleum recovered during ER 1,618,717 gallons
- ❑ Impacted soil removal amount Post ER 20,000+ cubic yards
- ❑ Access agreements are being worked out with individual owners
- ❑ Soil Removal is ongoing at GFL
- ❑ MSD Northern Basin oil recovery is ongoing.

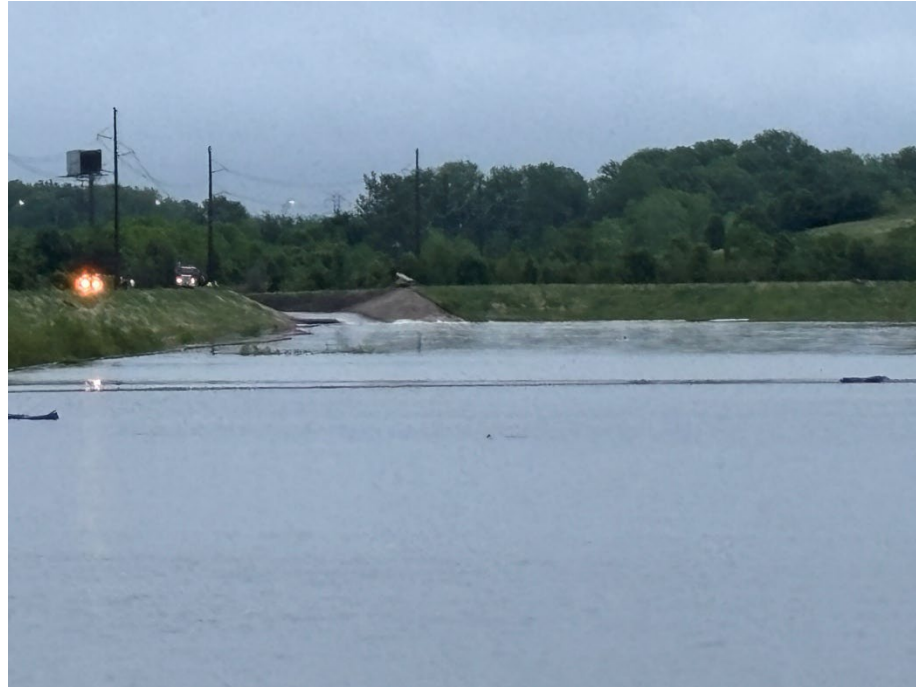
# Recovery Actions (KDEP)

- **MSD Northern Basin Operation**
- The Basin capacity is 55 million gallons
- $\frac{3}{4}$  of the storm water in the area is being re-routed to treatment area and then sent to local wastewater treatment plant.
- Treatment system can treat per system 1 million gallons per day. Currently there are 2 systems operating.
- The goal is to evacuate all water from basin and begin remediation of the basin during summer months if possible. Weather depending?
